Manhole Inspection Summary

Manhole # S25WW1012MH

Insp Date: **5/2/07 7:45 PM**

Location Address: **103 DEEPDENE RD**

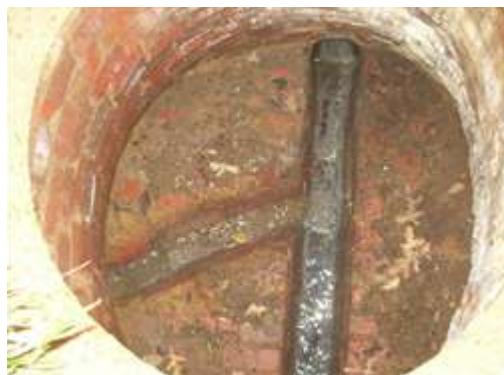
Top View

☒ **Debris** (not Condition related)

Bench debris.

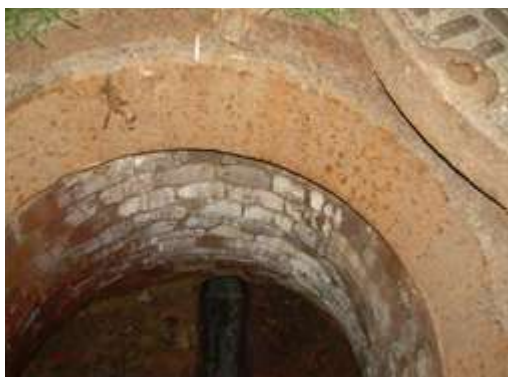
Defect

☒ **Leaks**

Infiltration: ☐ None ☒ **Joint** ☐ Cracks ☐ Mortar ☐ Roots ☒ **Wall**

Frame leaks. Adjustment infiltration.

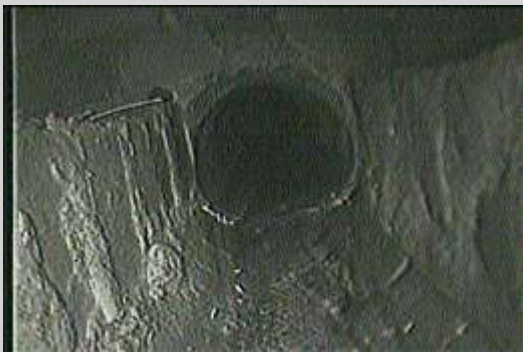
Pipe Out @ 12 O'Clock

Infiltration: **Evidence** Pipe Seal Cond: **Cracked**

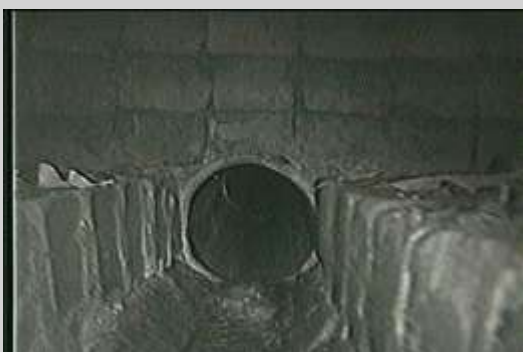
Pipe In @ 6 O'Clock

Infiltration: **Evidence** Pipe Seal Cond: **Cracked**

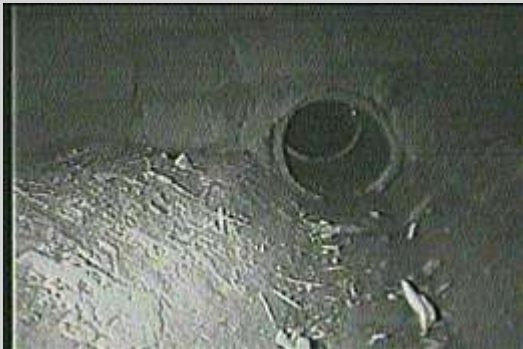
4 in. Circular Gravity Sewer
Pipe In @ 8 O'Clock

Infiltration: **None** Pipe Seal Cond: **Unknown**
